1. REPORT DATE (DD-MM-YYYY) 14-07-2005		2. REPORT TYPE Technical Report		3. DATES COVERED (From - To) Aug 03-Apr 05
4. TITLE AND SUBTITLE Bonded Repair of Corrosion Grind-Outs		5a. CONTRACT NUMBER F05611-03-D-003		
		5b. GRANT NUMBER		
		5c. PROGRAM ELEMENT NUMBER

The US Air Force is operating a large fleet of aging aircraft. Some examples of problems that aging aircraft can encounter are fatigue and corrosion. This research focuses on bonded repair of exfoliation corrosion in the upper wing skin of the E-8C Joint Star (B707) military transport aircraft.

The purpose of the current research is to develop a flush bonded repair method that restores structural integrity to corrosion grind-outs deeper than 25% of the skin thickness, so that severe corrosion cases can be handled without costly repair.

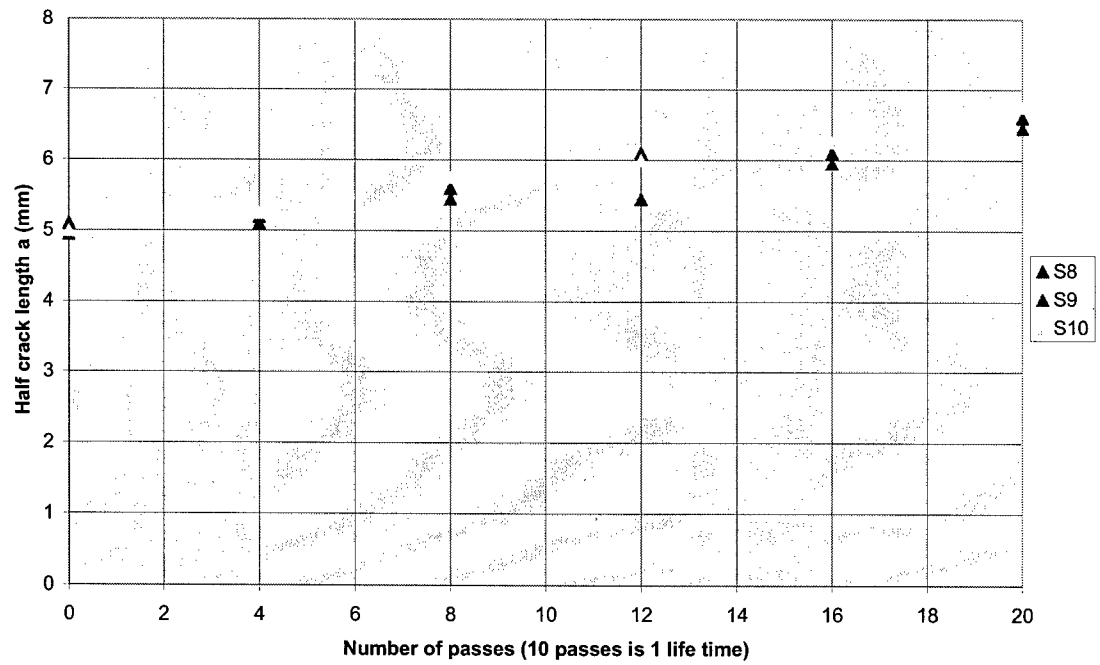
Figure 34: Specimens with hybrid repairs, spectrum loading

As can be seen from Figure 34 through Figure 36, the hybrid repairs are clearly performing the best, showing the smallest crack growth over two life times. None of the three hybrid repairs showed any signs of disbonding or delaminations after completion of the test, see appendix B.9. Also, no signs of patch cracking in the aluminum layer and no signs of patch tip failure in the skin were observed. Besides controlling the starter crack very well over two full life times, there was no crack initiation at any of the other rivet holes. Since the assumption is that there is no crack in the remaining substrate after making the grind-out, this is a good indication of the performance under realistic loading conditions.

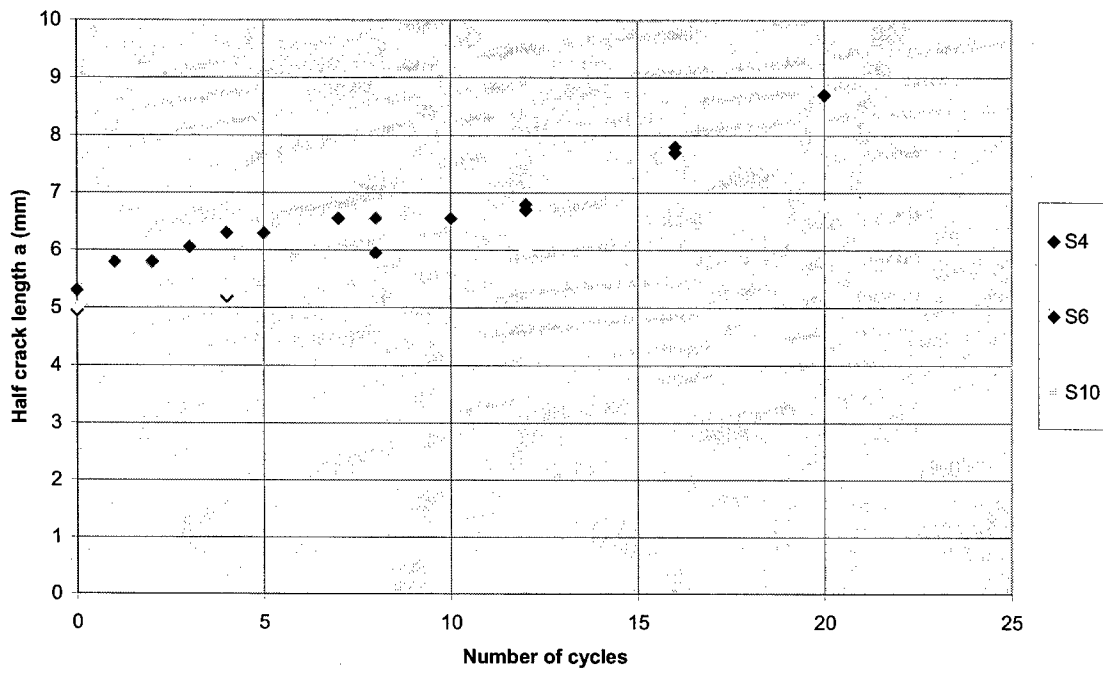
Figure 35: Spectrum specimens with three different repairs, spectrum loading

Table 6 shows the specimens that were tested under spectrum loading. Figures 31 through Figure 34 show the crack growth curves for the unrepaired specimens and the three different types of repairs. Figure 35 shows a comparison of the different types of repair, and Figure 36 shows the same curves as Figure 35 but now with the unrepaired specimen included.

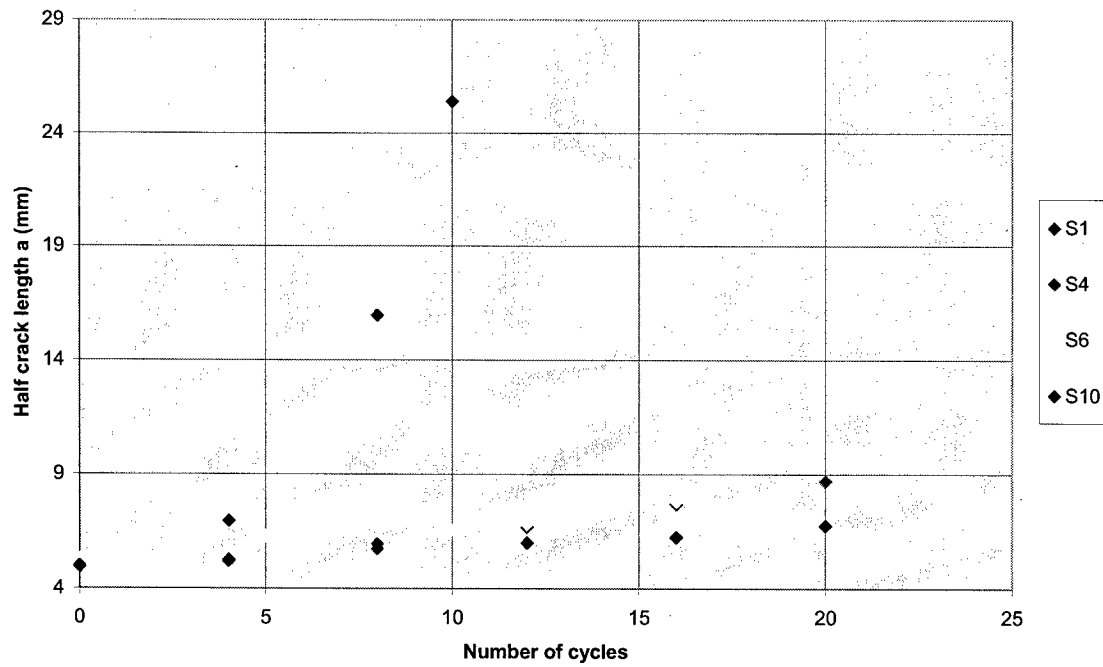
Figure 36: Spectrum specimens with and without repairs, spectrum loading
